# Manhole Inspection Summary

Manhole # S43W1\_003MH

Insp Date: **4/16/08 12:51 PM**

**Location** Address: **900 9th St.**

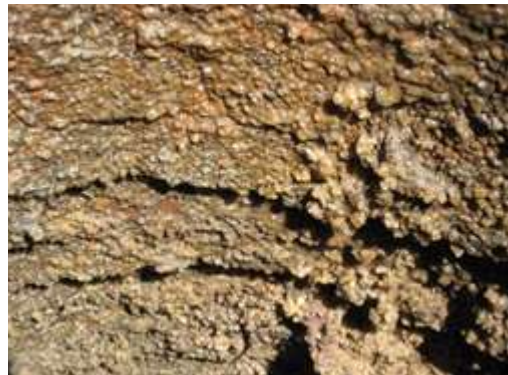
Defect 2

Infiltration

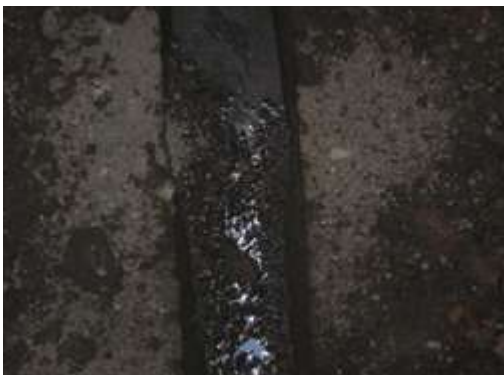
Defect 1

Debris on bench and channel

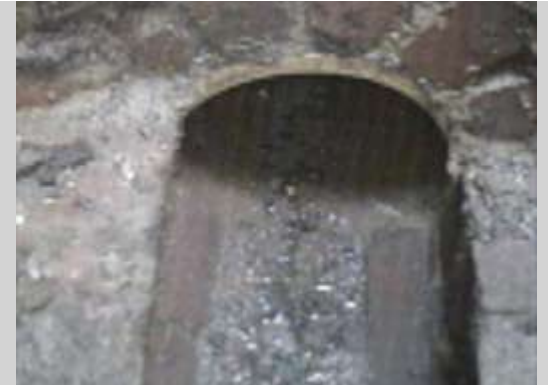
12 O'Clock Outflow

8 in. Circular Gravity Sewer  
Pipe Out @ 12 O'Clock

Pipe Height: **8.4** (in.) Rod and Bar (Angled)  
Pipe Material: **Clay** ☐ Pipe Lined  
Invert Depth: **10.30** (ft.) Flow Characteristics: **None**  
Deposits: ☐ None ☐ Mud ☐ Sludge ☒ **Debris** ☐ Grease  
Silt Depth: **1** (in.) Deposits Extent: **Light**  
Infiltration: **None** Pipe Seal Cond: **Sound**

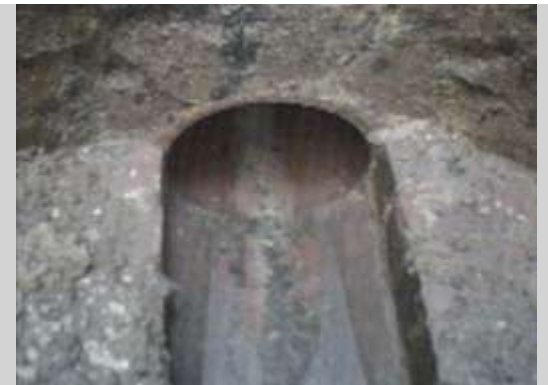
6 O'Clock Inflow

8 in. Circular Gravity Sewer  
Pipe In @ 6 O'Clock

Pipe Height: **8.4** (in.) Rod and Bar (Angled)  
Pipe Material: **Clay** ☐ Pipe Lined  
Invert Depth: **10.20** (ft.) Flow Characteristics: **None**  
Deposits: ☐ None ☐ Mud ☐ Sludge ☒ **Debris** ☐ Grease  
Silt Depth: **1** (in.) Deposits Extent: **Light**  
Infiltration: **None** Pipe Seal Cond: **Sound**
